EXPERIMENTAL INVESTIGATIONS OF A
FIN PROTUBERANCE PARTIALLY IMMERSED
IN A TURBULENT BOUNDARY LAYER AT MACH 5

Allen E. Winkelmann

NOLTR 72-33

21 January 1972

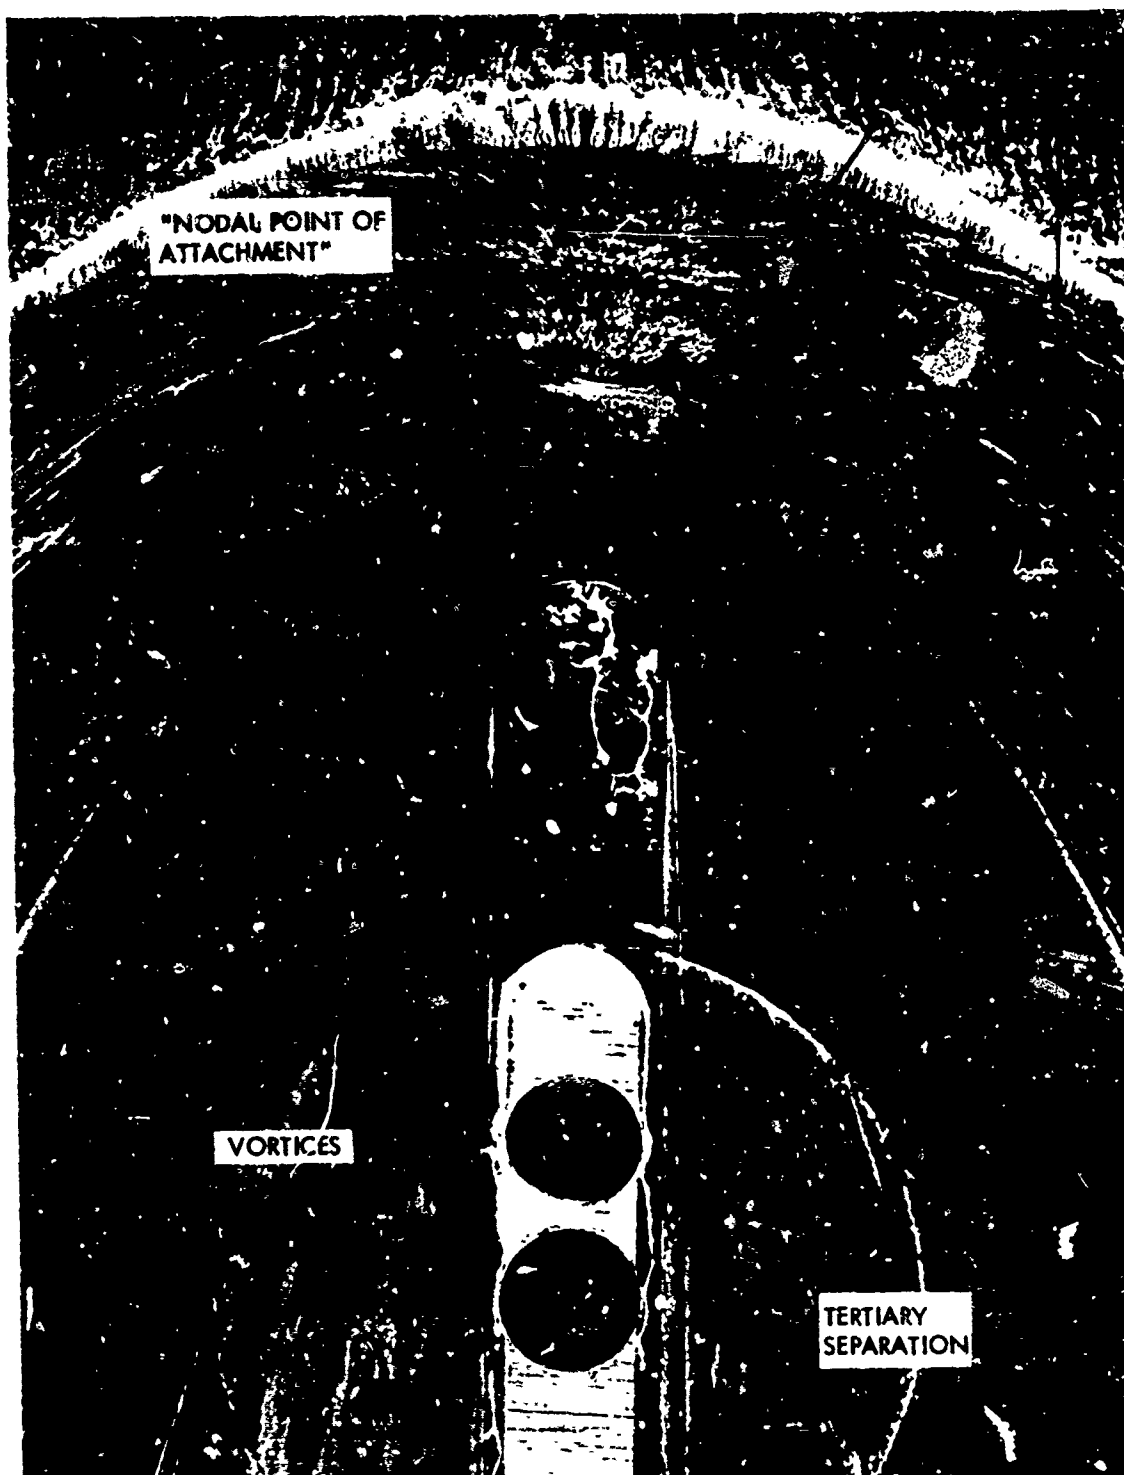
FIG. 22b ENLARGED VIEW-UPSTREAM OF UNSWEPT FIN

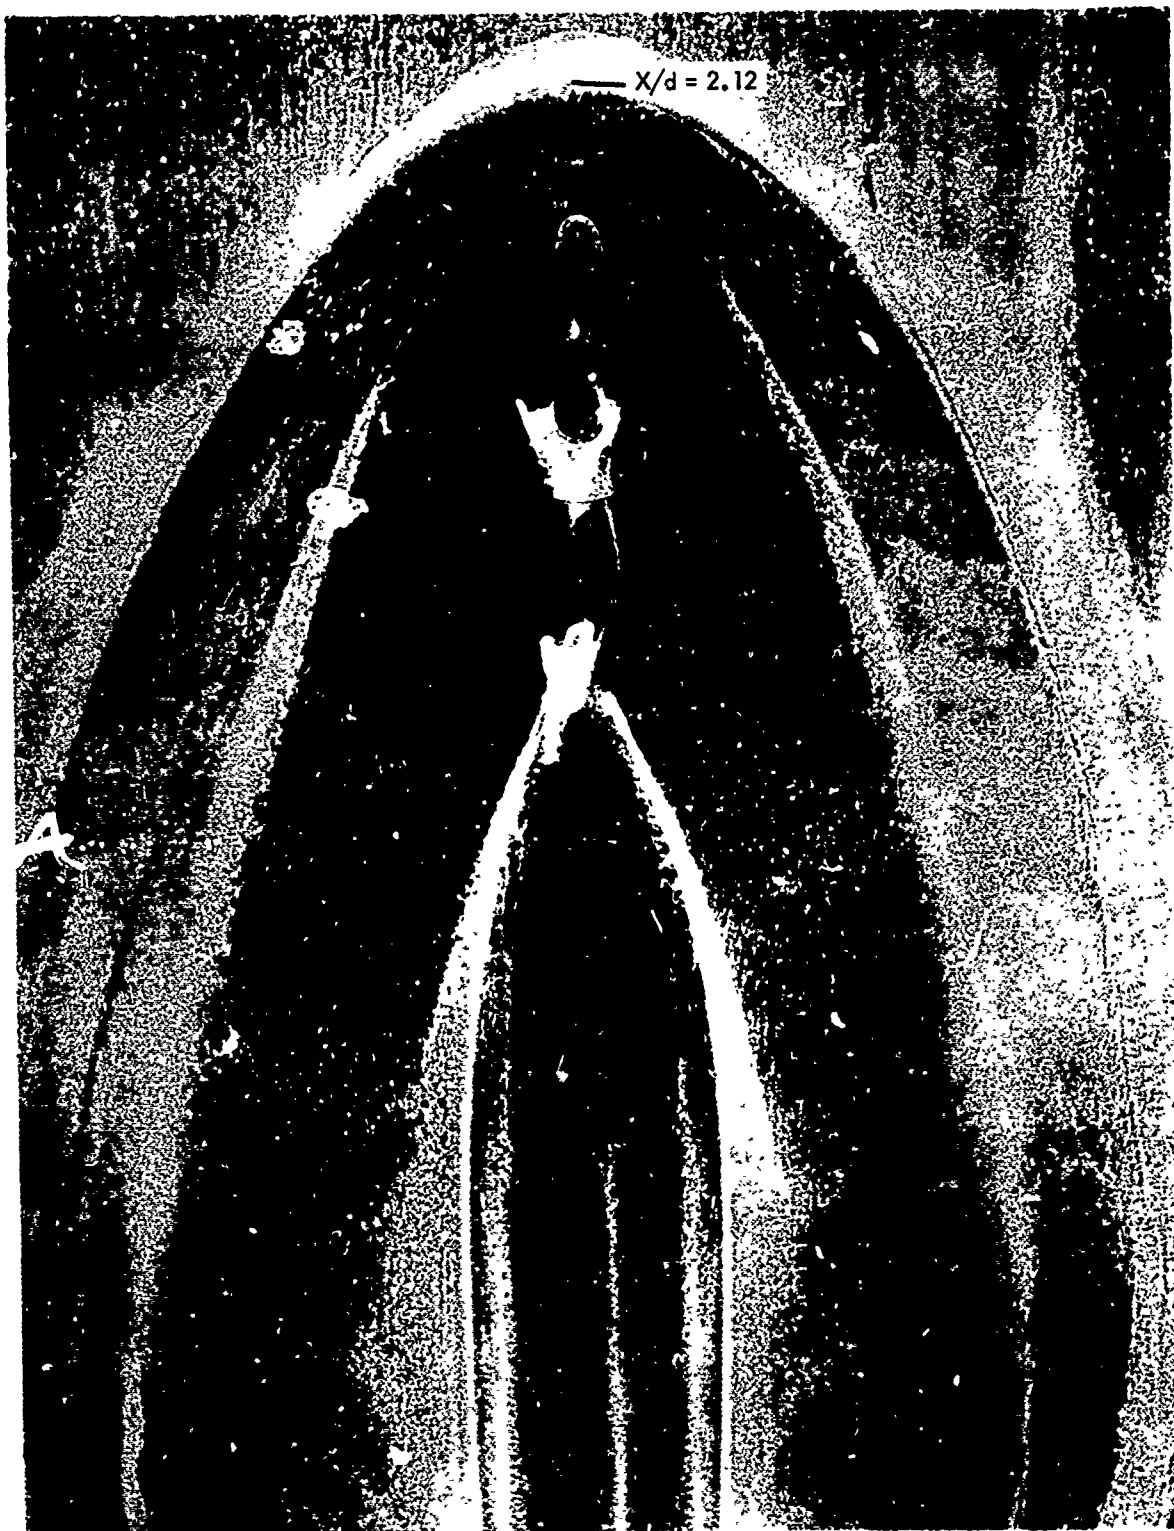
FIG. 24 UNSWEPT FIN WITH 0.125" CLEARANCE GAP

to develop at the leading edge of the clearance spacer. The patterns on the plate and fin develop as before and regions noted in the oil smear photographs of Figures 24 and 30b can be identified. In particular the "hairpin" region (HP) of flow separation noted in the oil smear photograph is apparent under the forward part of the fin ($t = 2.2$). Regions of high heating are noted under the rearward part of the fin ($t = 3.4$) and these are associated with high levels of pressure measured in this region (Figure 12b).

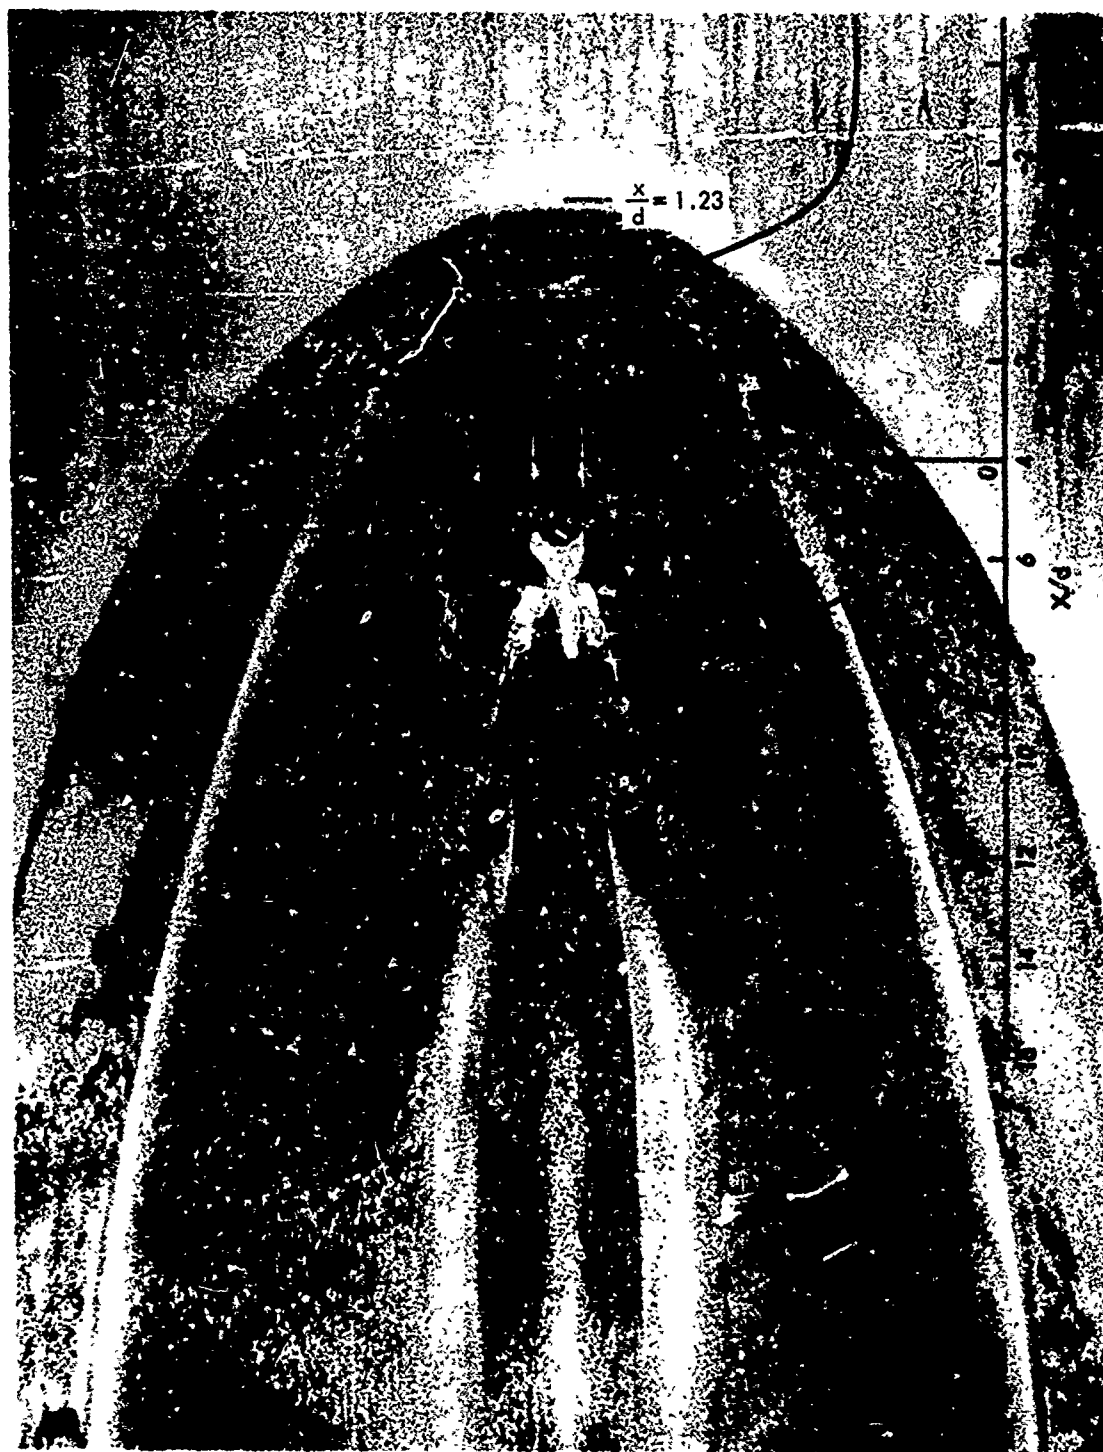
FIG. 26a UNSWEPT FIN WITH 0.5" CLEARANCE GAP

Increasing the gap size produced a rather noticeable change of the flow field in the wake region of the fin. This was also noted in the pressure data of Figure 13. A superposition of the pressure data on Figure 26a clearly indicates how regions of varying shear flow shown by the oil smears correspond to the variation in the pressure distribution. An enlarged view of the oil pattern produced with the 0.5-inch spacer is shown in Figure 26b. Again the type of flow structure apparent in Figure 23b is to be observed here. Now however, it appears that a "stagnation line" has developed just ahead of the spacer.

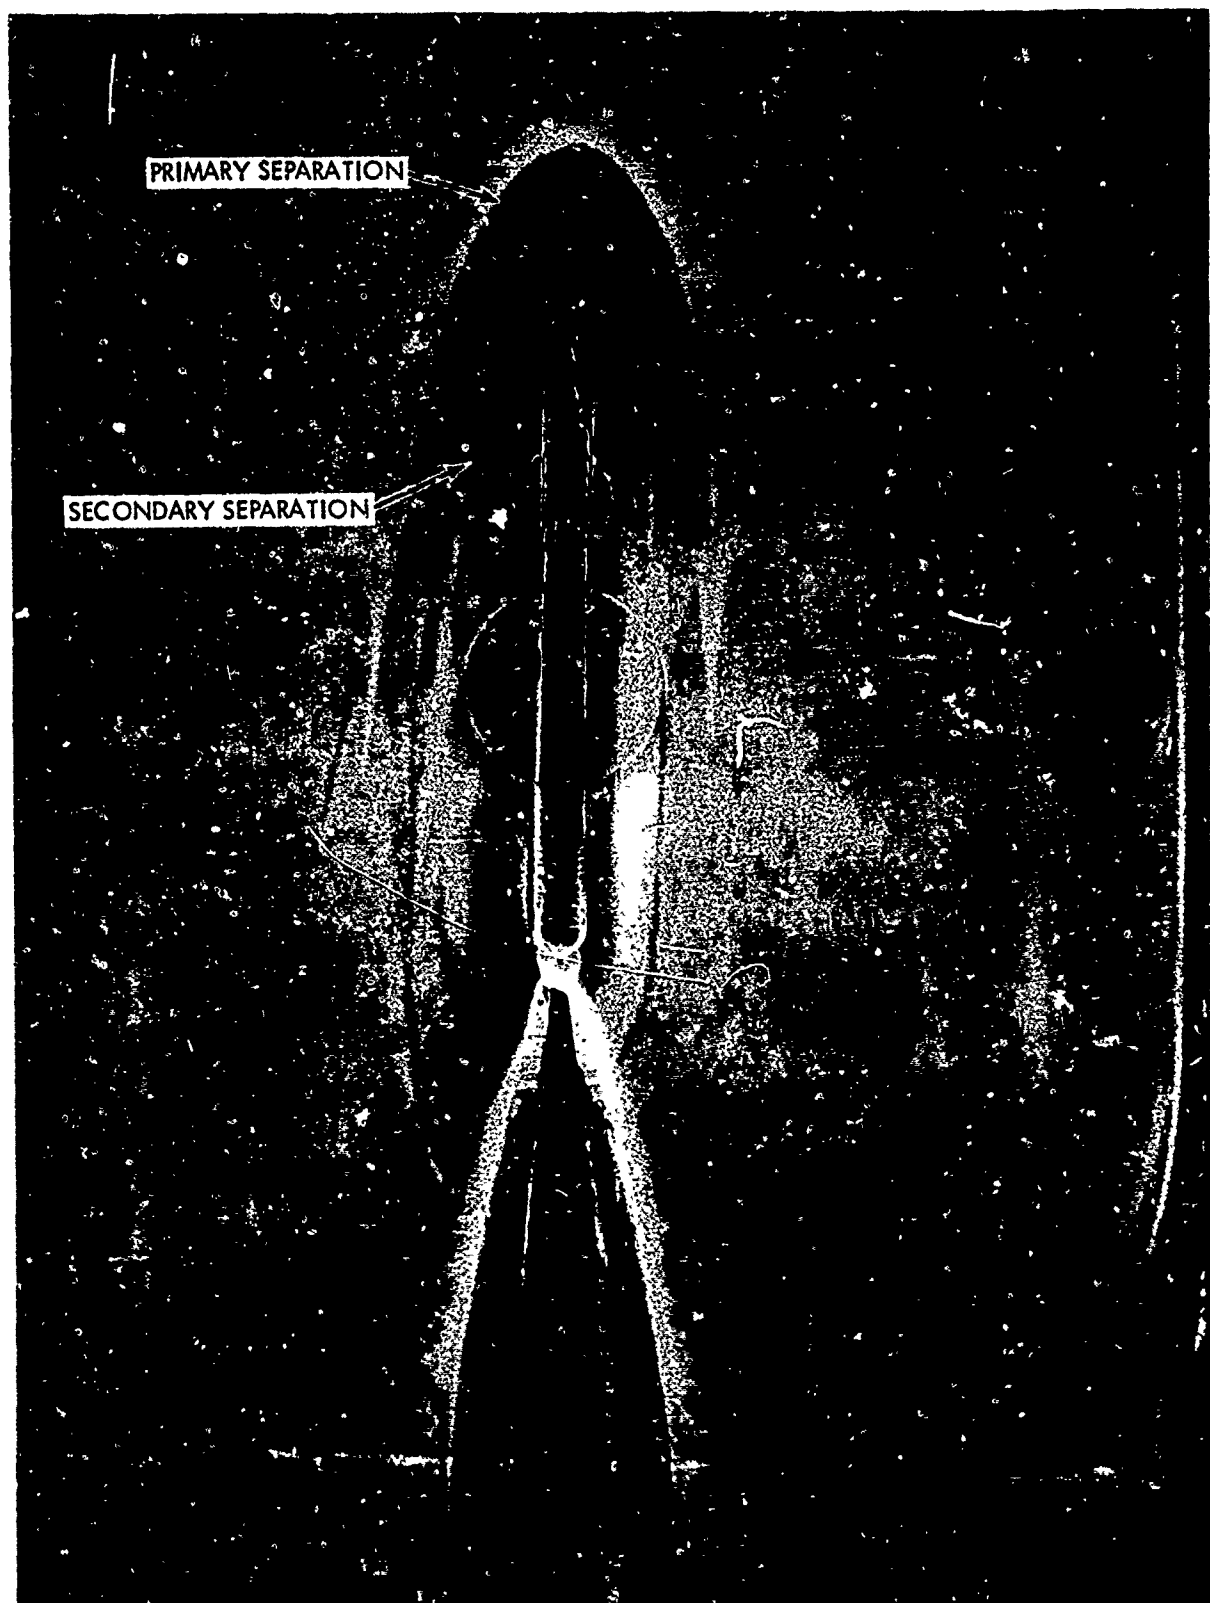
FIG. 27a OIL PATTERN ON THE FLAT PLATE FOR A 60° SWEEP FIN

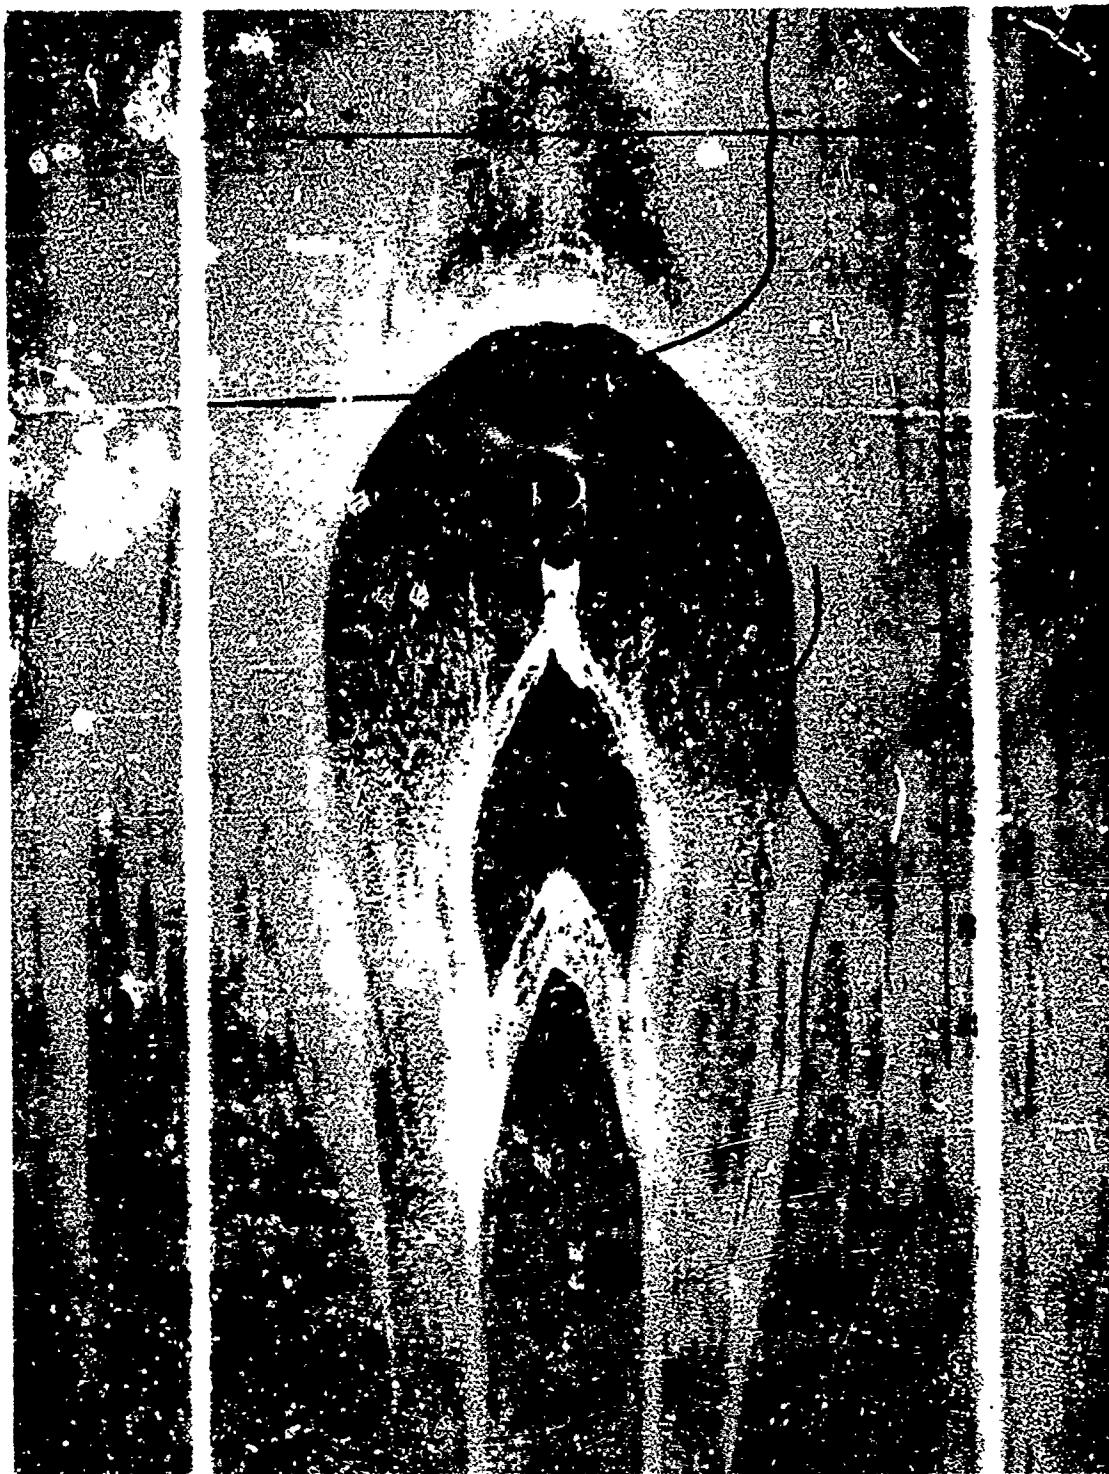
FIG. 29a 60° SWEEP FIN WITH 0.5" CLEARANCE GA
